Limited Visual Dam Safety Inspection Summary Report

MA-096

Pauwela Reservoir

Limited Visual Dam Safety Inspection Conducted on: 05 April 2006

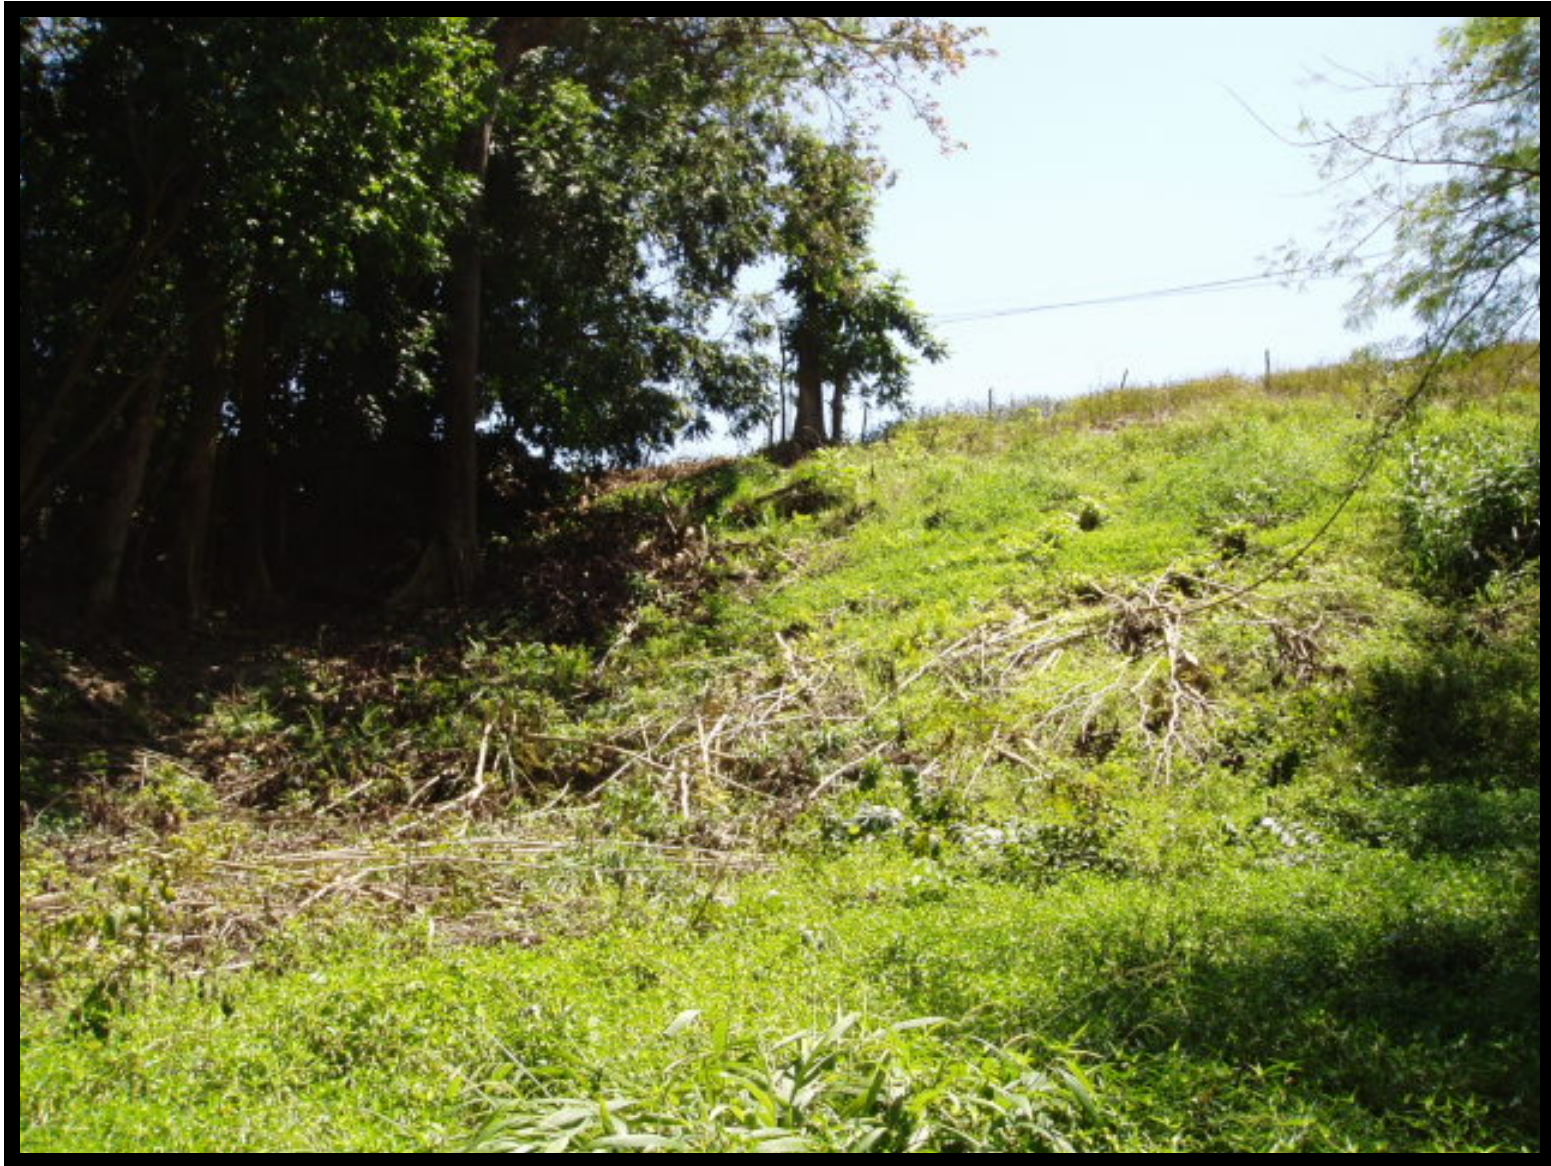
There was dense vegetation and inspection could not be conducted in a few areas for erosion, cracks and sinkholes.

There was one large tree near left abutment contact.

096 Downstream slope of the dam (panorama) 1

- a. The downstream slope appeared to be in fair to poor condition and requires corrective action.
- b. The downstream slope was not visible due to high grass and bush vegetation. Clear high vegetation and maintain low to enable easy visual inspection.

- c. Tree(s) were observed on the downstream slope. Trees have been identified as the probable cause of piping failures, and can possibly cause severe damage to the embankment if they are uprooted during high winds. Corrective action is required to remove the tree hazards from the dam. Acceptable remedies include removal of the tree and its root structure down to a 2" diameter and reconstructing the damaged embankment section. All repair work shall be accomplished as per the requirements of a licensed geotechnical or structural engineer. Routinely monitor the damaged area for signs of settlement and seepage.

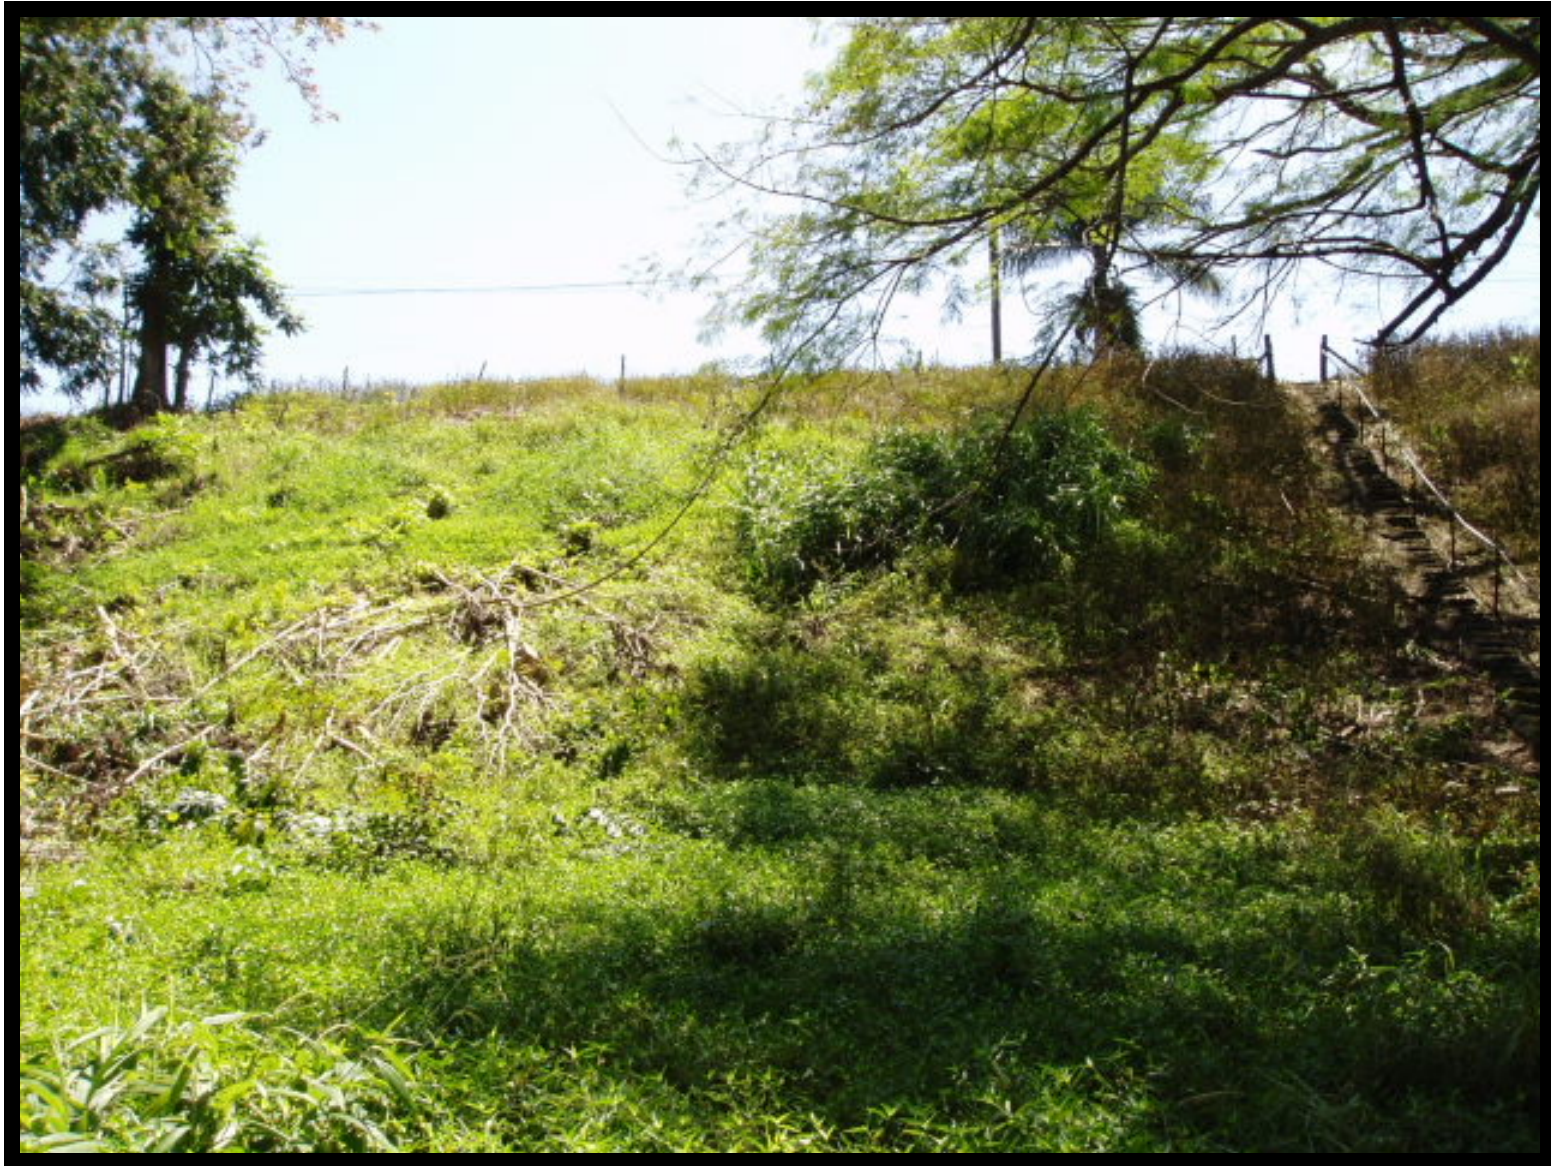
096 downstream slope of the dam (panorama) 2

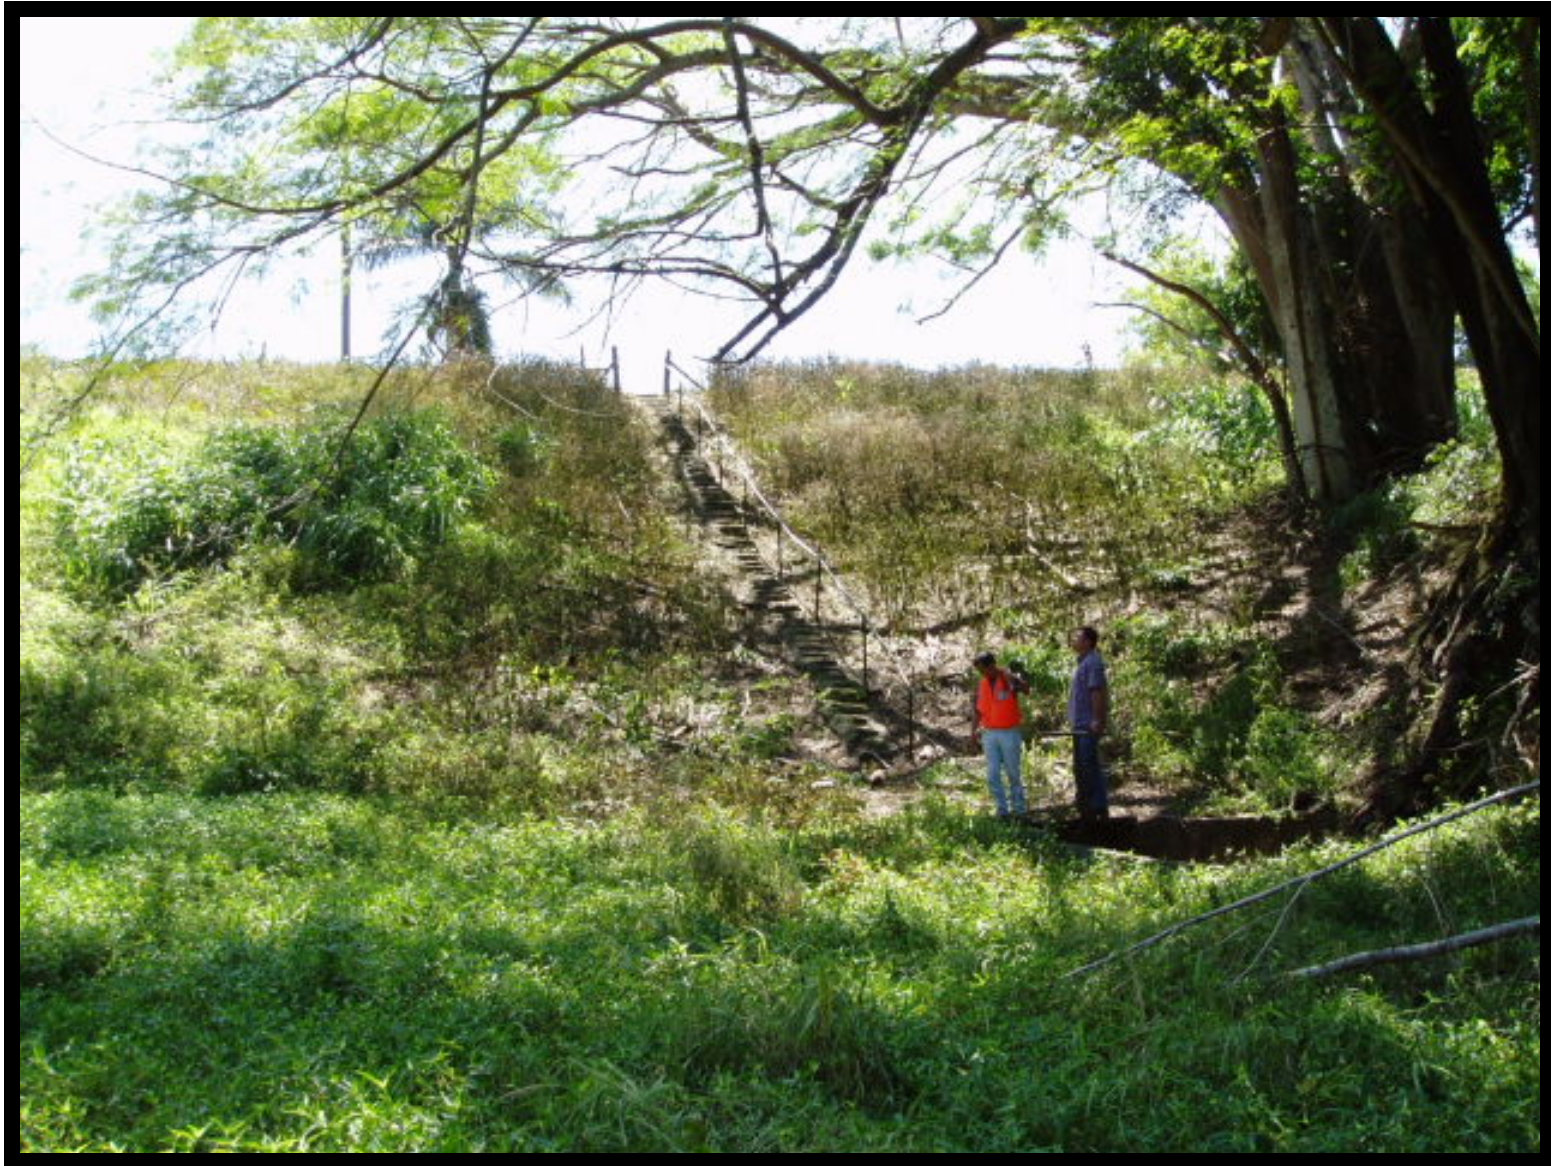
096 downstream slope of the dam (panorama) 3

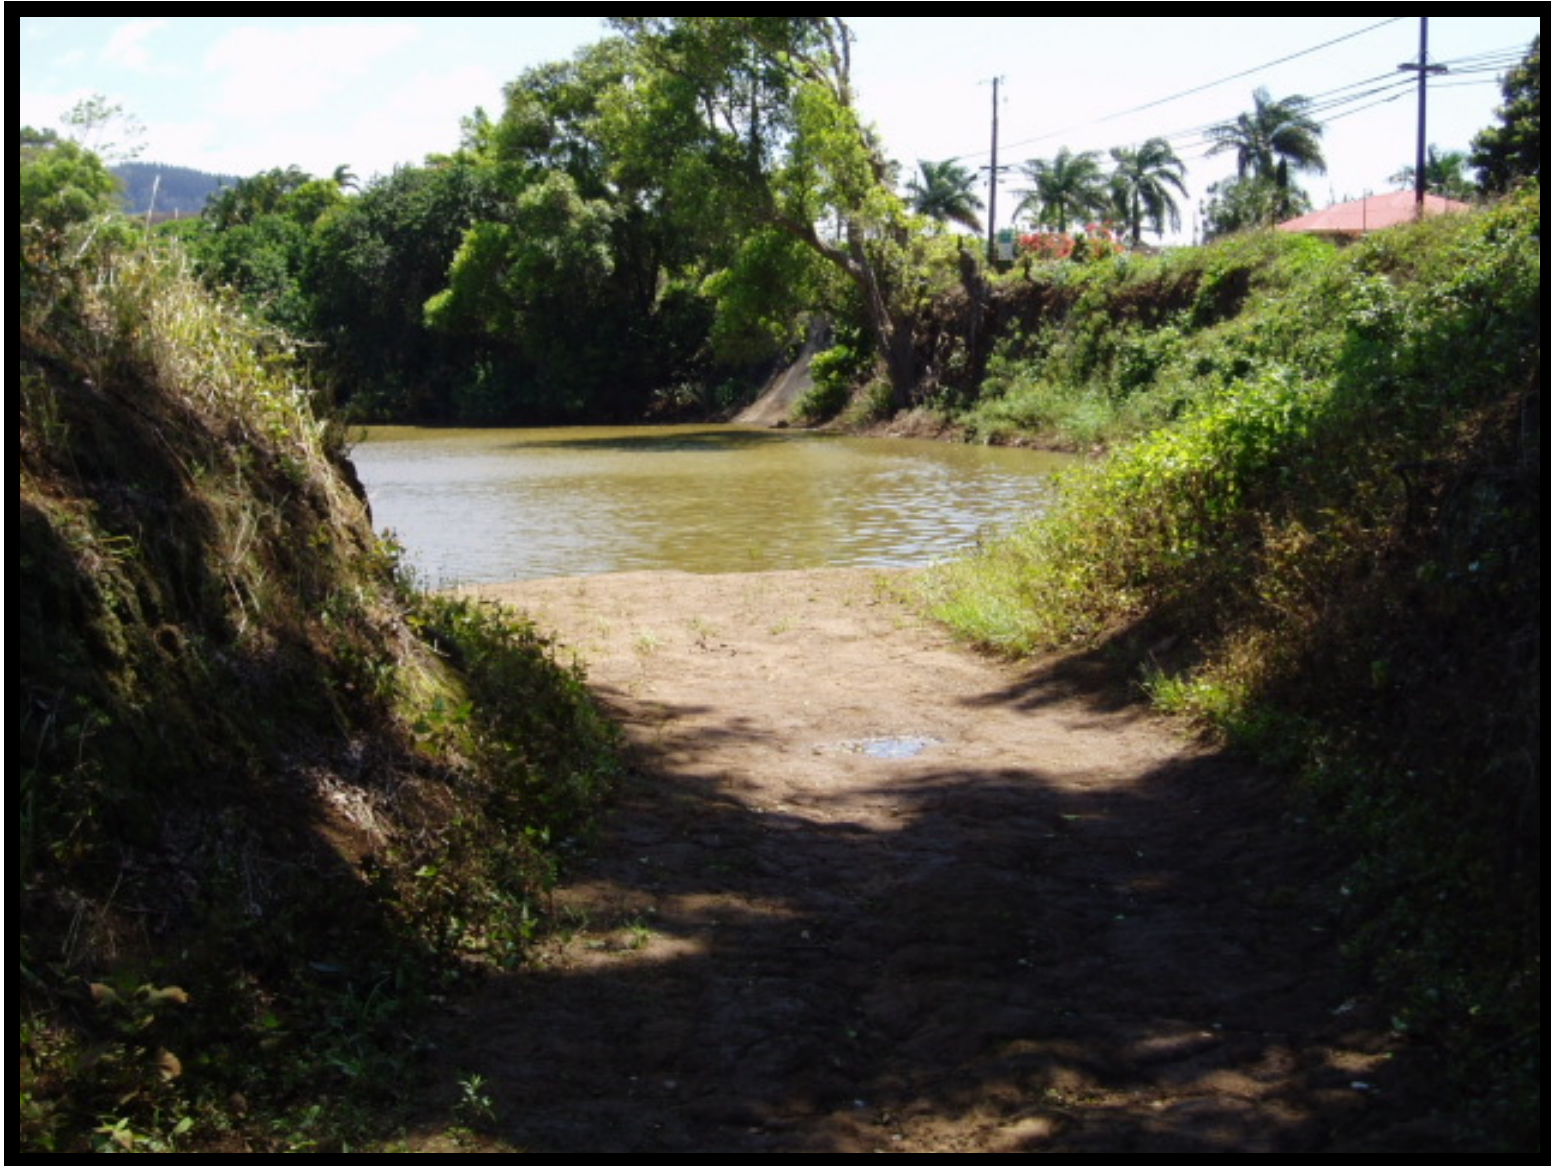
The spillway approach was clear.

Erosion was not observed at the time of inspection.

096 spillway - Spillway approach channel. Spillway channel is good condition.

- a. The Spillway appeared to be in satisfactory condition, no corrective actions are required at this time.

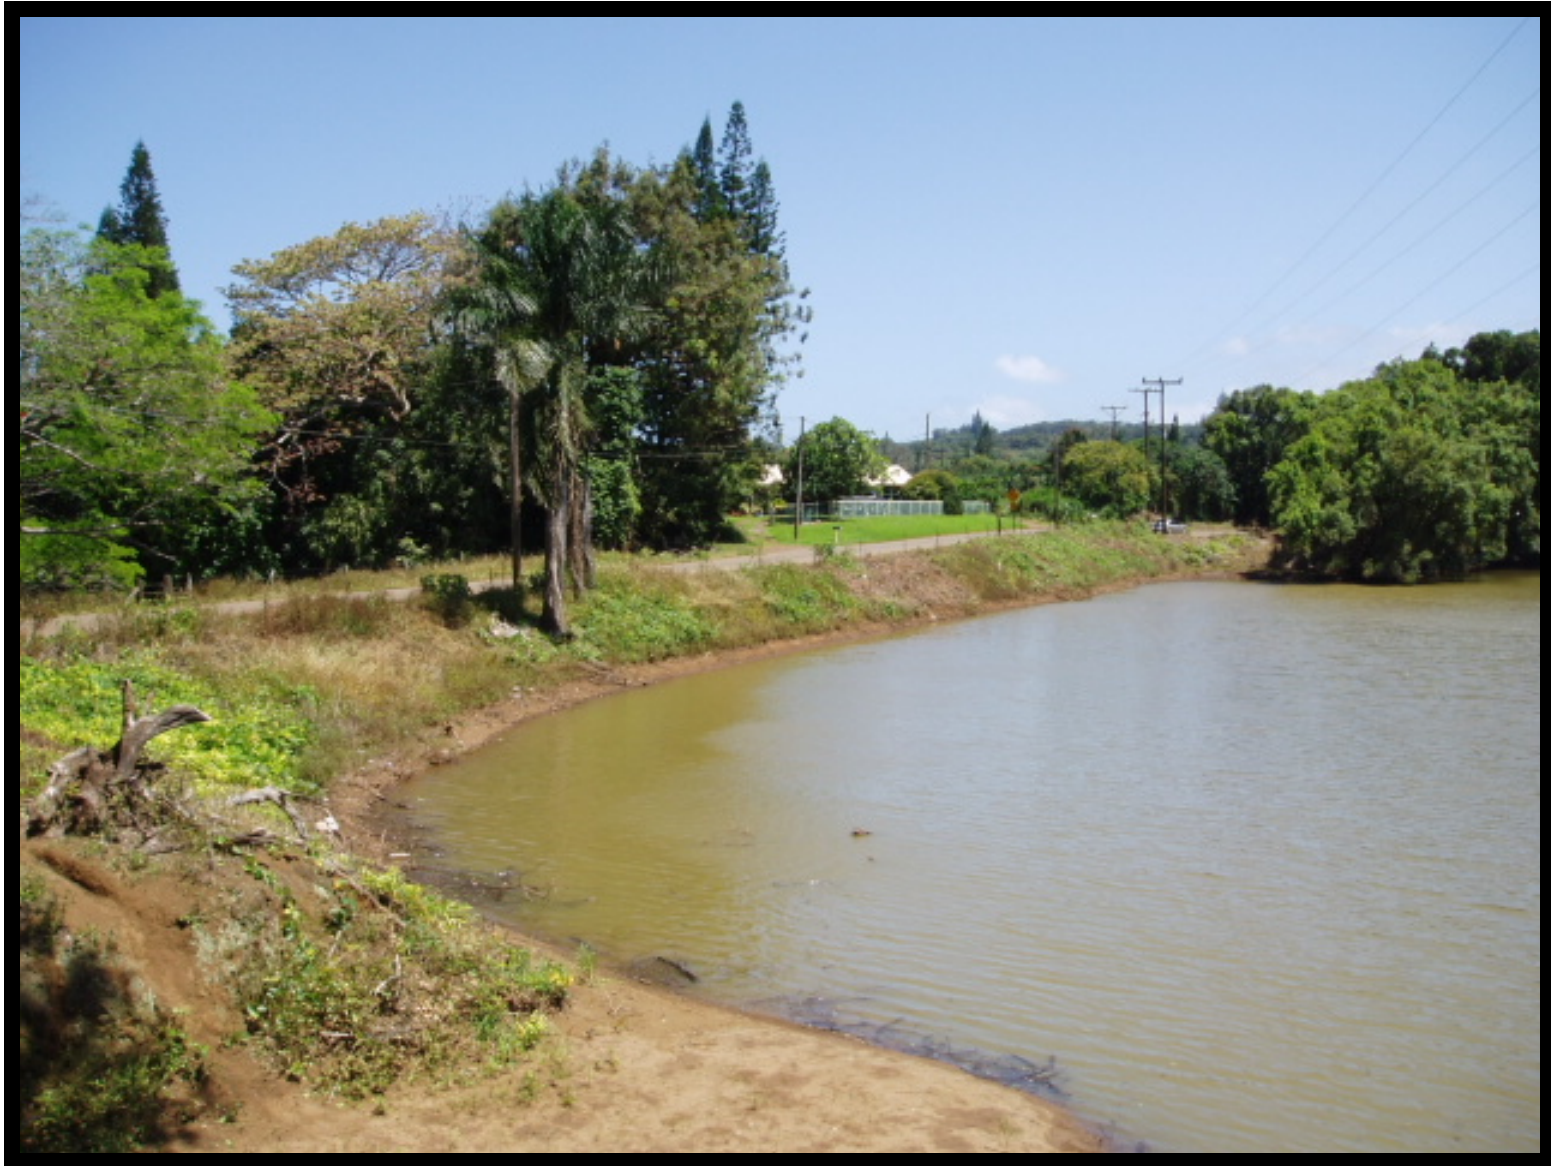
Some areas of upstream slope could not be inspected for erosion due to dense vegetation.

Some areas of the slope were not visible due to the tall grass. One palm tree on the slope. The palm tree should be removed.

096 upstream slope of the dam and reservoir.

- a. The upstream slope appeared to be in fair to poor condition and requires corrective action.
- b. The upstream slope was not visible due to high grass and bush vegetation. Clear high vegetation and maintain low to enable easy visual inspection.
- c. Tree(s) were observed on the dam embankment. Trees have been identified as the probable cause of piping failures, and can possibly cause severe damage to the embankment if they are uprooted during high winds. Corrective action is required to remove the tree hazards from the dam. Acceptable remedies include removal of the tree and its root structure down to a 2" diameter and reconstructing the damaged embankment section. All repair work shall be accomplished as per the requirements of a licensed geotechnical or structural engineer. Routinely monitor the damaged area for signs of settlement and seepage.
